North West & Central (NW&C) Region

North West Route

**Moorgate Halt Level Crossing
Impact Risk Assessment Report**

Report Reference:	IAR/MVL3/13.26
-------------------	----------------

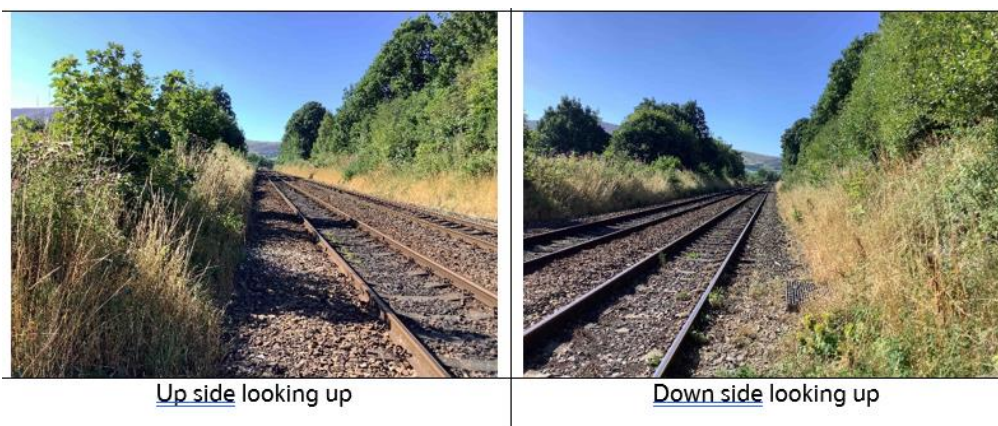
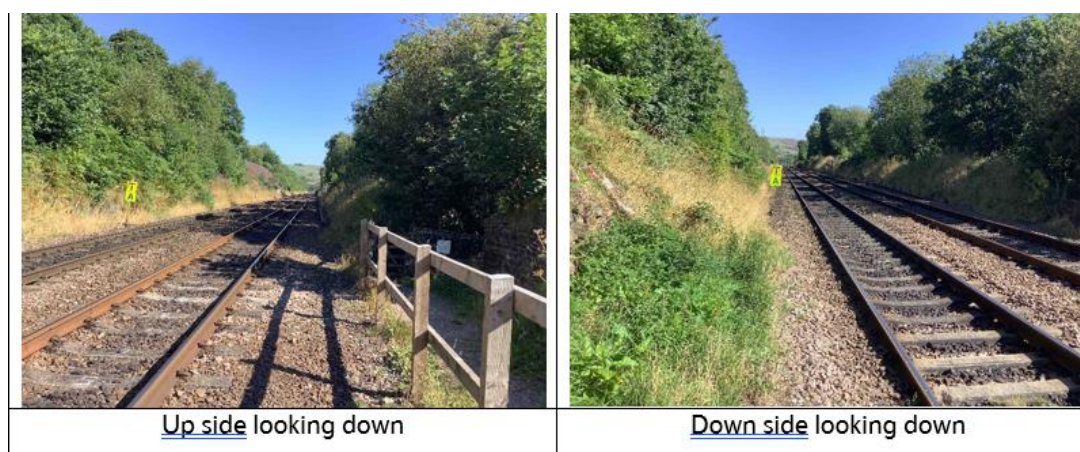
- 5.2.4. The available sighting on the down side looking towards the train approach is significantly less than the required due to track curvature. As a result, a temporary speed restriction has been imposed at 55mph.

- 5.2.5. When stood on the down side looking towards train approach the sighting is deficient by 44 metres giving a user 1.51 seconds less than the required warning time to cross.

- 5.2.7. The Transpennine Route Upgrade are increasing their linespeed as part of the railway improvement works and the full benefit of the project will not be achieved if a temporary speed restriction remains on the crossing

- 5.2.8. Based on the improved 80mph line speed, users of the Crossing require a minimum of 406m of sighting in order to cross in safety.
- 5.2.9. The available sighting on the down side looking towards the train approach will be significantly less than the required. When stood on the down side looking towards train approach the sighting is deficient by 120 metres giving a user 3.35 seconds less than the required warning time to cross.
