## Local Heritage Listing Project

Failsworth East,  
Oldham

**Gazetteer of Validated  
Candidates**

June 2025

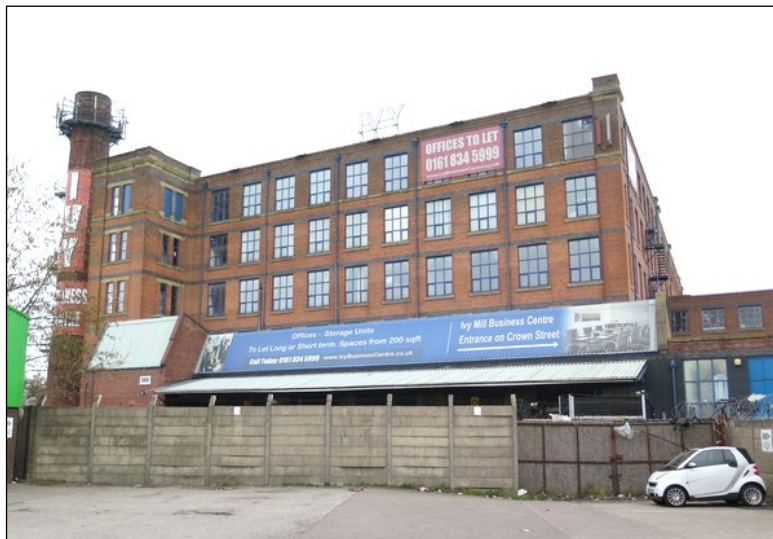
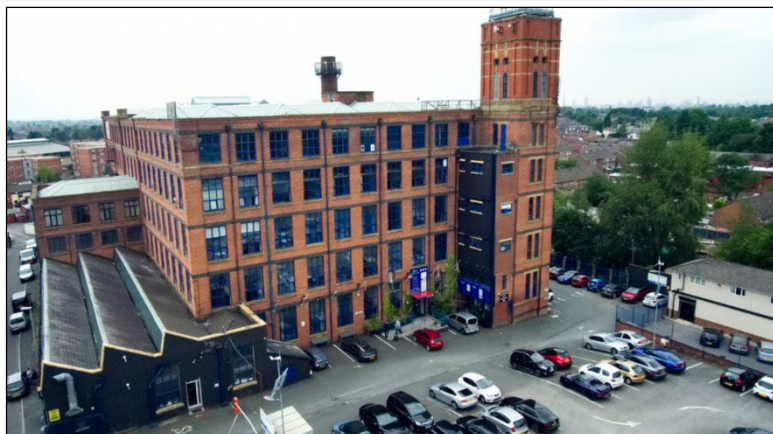
Ivy Mill – HER 6073.1.0

| <b>Significance</b> | <p><i>Historic Interest:</i> Built in 1883 by George Schofield. Extended in 1890-1, 1896 and several more times before 1921. The original engine of 430hp supplied by Timbly Bates was replaced in 1890 by a Pollit &amp; Wigzell engine of 650hp. Ceased production in 1934.</p> <p><i>Architectural Interest:</i> Five storeys and basement, of dark brick with blue-brick decoration, 20 by 12 bays, corner turrets, water tower, internal engine house and chimney on canal front. There is some blue brick embellishment between the storeys.</p> <p><i>Local Interest:</i> Considerable local interest as a part of legible historic physical, economic and social evolution and functioning of the wider area.</p> <p><i>Aesthetic Value:</i> The aesthetic interest remains considerable.</p> <p><i>Social / Community Value:</i> The building was one of a number of mills that dominated life within the local area for many years including by providing direct and associated employment opportunities. The building retains its role as a cultural reminder with the associated social and community value.</p> <p><i>Group Value:</i> The mill has a strong group value with the adjacent canal.</p> <p><i>Landmark Status:</i> The mill is a dominant feature within the local streetscape.</p> |

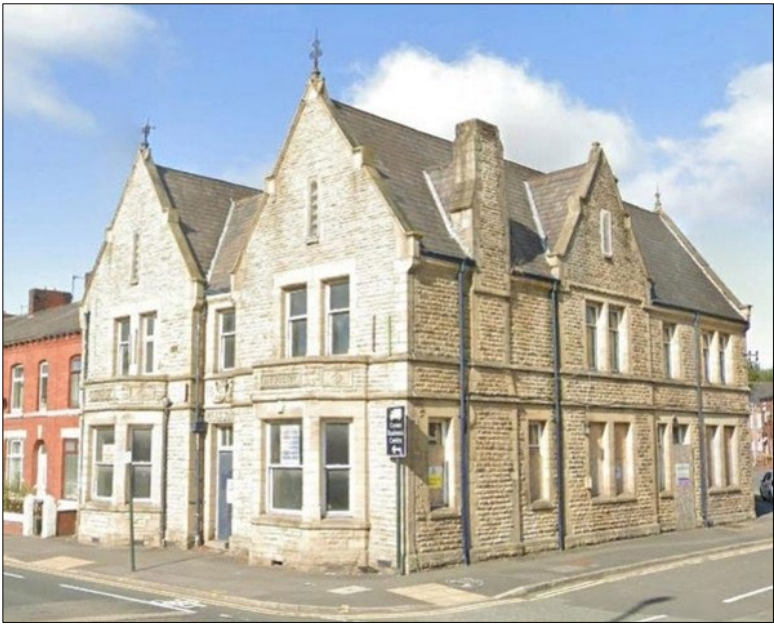
| <b>Significance</b> | <p><i>Historic Interest:</i> A former police station that was opened in 1892. The building is a built reminder of the evolution of the locality in built terms and the way in which it, and wider society, functioned including in terms of law enforcement and the increasing provision of public services.</p> <p><i>Architectural Interest:</i> The building was designed by William Telford Gunson, who was the architect for several police stations across the district. It was sold at auction for £190,000 in February 2016. It was described as a two-storey (plus basement) end of terrace former police station premises.</p> <p><i>Local Interest:</i> As a local law enforcement centre for over 120 years, it was instrumental in community policing—handling crime, public safety, and fostering trust with residents.</p> |

| | <p><i>Aesthetic Value:</i> The building has considerable aesthetic value and makes a positive contribution to the historic streetscape.</p> <p><i>Group Value:</i> The building has group value with the surviving nearby, broadly contemporaneous. elements of the historic urban streetscape including the attached terraces of housing.</p> <p><i>Social / Community Value:</i> The building served the local community as a police station for over a hundred years. It is a notable building within the area in terms of its original use and design and contributes to a sense of place.</p> <p><i>Landmark Status:</i> The prominent corner location and high-quality design make this a notable building within the area.</p> |

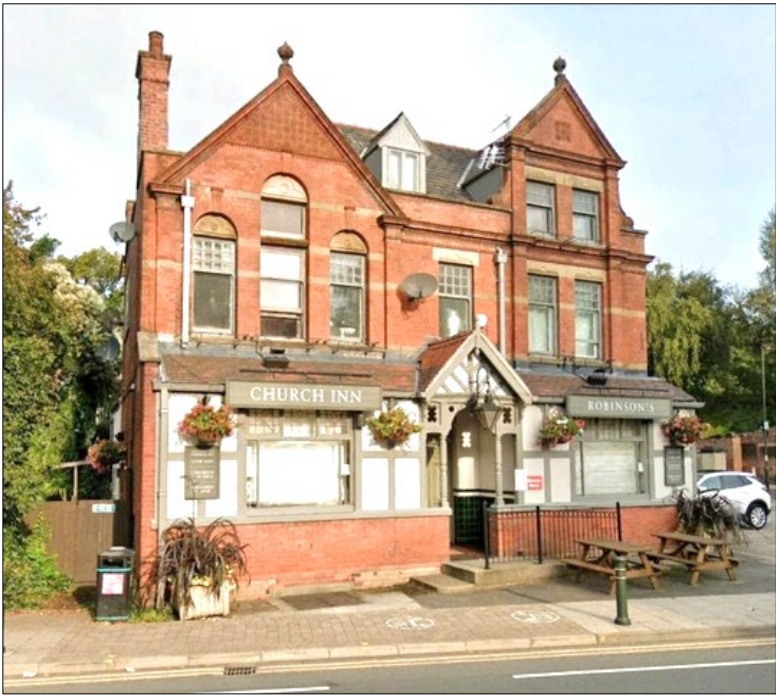
| <b>Significance</b> | <p><i>Historic Interest:</i> The Church Inn seems to have been acquired by Kays Atlas Brewery in the early 1890s, and this company was responsible for building the extant pub.</p> <p><i>Architectural Interest:</i> The inn is a detached, unsymmetrically double-fronted, two-storey plus attic accommodation provided as a part of the original design as indicated by gable and dormer windows. Looking at the principal (Oldham Road) elevation the first floor room on the left hand side is served by three windows with a taller central window indicating a function room with added height extending into the roof space.</p> |

| | <p><i>Local Interest:</i> The origins of the inn can be traced to 1767, when John Clegg opened the Three Crowns. Thomas Wilson took the licence in 1850 and changed it to the Church Inn.</p> <p><i>Aesthetic Value:</i> The building has considerable aesthetic value and makes a positive contribution to the area's character.</p> <p><i>Group Value:</i> The building has group value with the surviving nearby, broadly contemporaneous. elements of the historic urban streetscape including the church opposite.</p> <p><i>Social / Community Value:</i> The building continues to serve the local community as a public house. It is a notable building within the area and contributes to a sense of place.</p> <p>Landmark Status: The building is a notable feature of the Oldham Road streetscape.</p> |

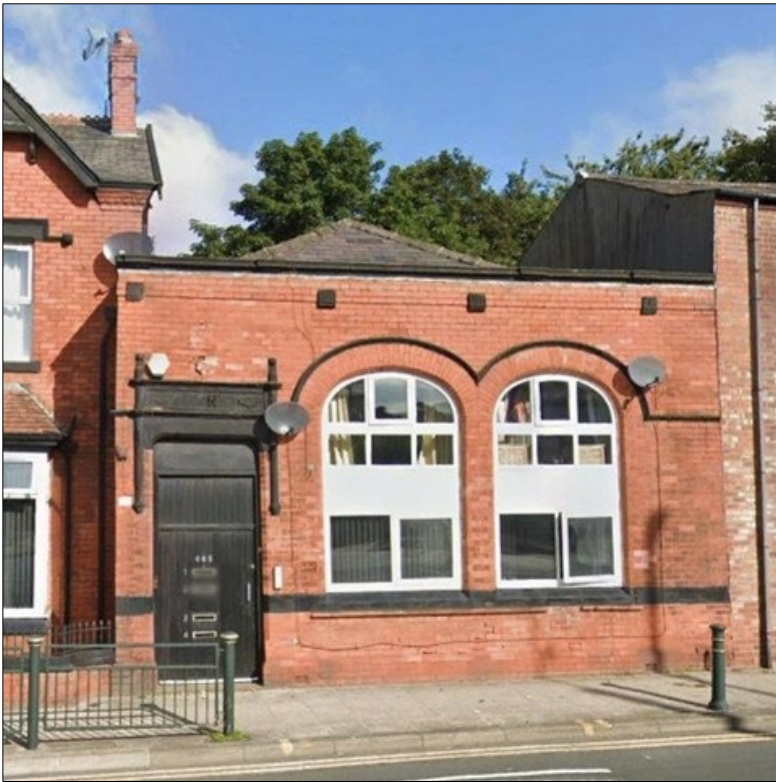
| <b>Significance</b> | <p><i>Historic Interest:</i> A former bank forming part of a short terrace on the northern side of Oldham Road, first shown on the Ordnance Survey 1st Revision 1:2500 map of 1909.</p> <p><i>Architectural Interest:</i> The single-storey front elevation contains the oversized entrance door (with decorative stone lintel) and a pair of oversized arched windows to the east. The building has a hipped slate roof, hidden partially behind</p> |

| | <p>a brick parapet with stone coping. The building externally is an interesting survivor of a modest bank branch building retaining a strong sense of the original design intent.</p> <p><i>Local Interest:</i> The building is an interesting survivor of a modest branch bank evidencing the urban evolution of both the surrounding locality and the banking industry.</p> <p><i>Aesthetic Value:</i> The building is modest in both size and design aspiration but the front elevation in particular retains a sense of the original external design intent.</p> <p>Landmark Status: The former bank is an interesting feature of the historic streetscape.</p> |

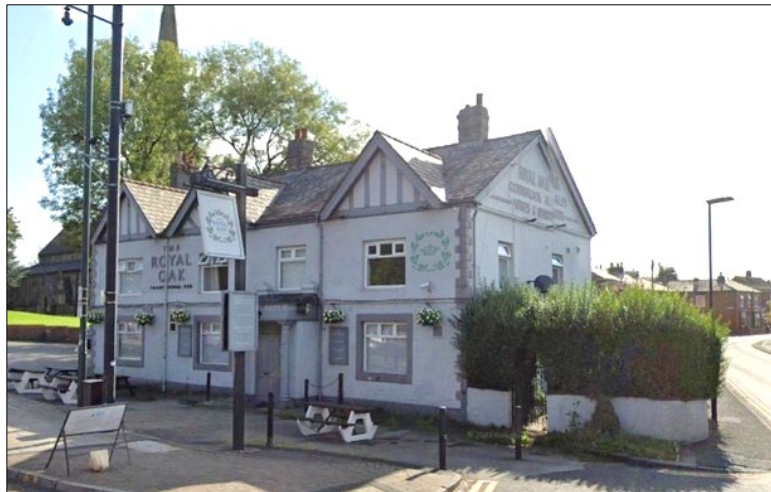
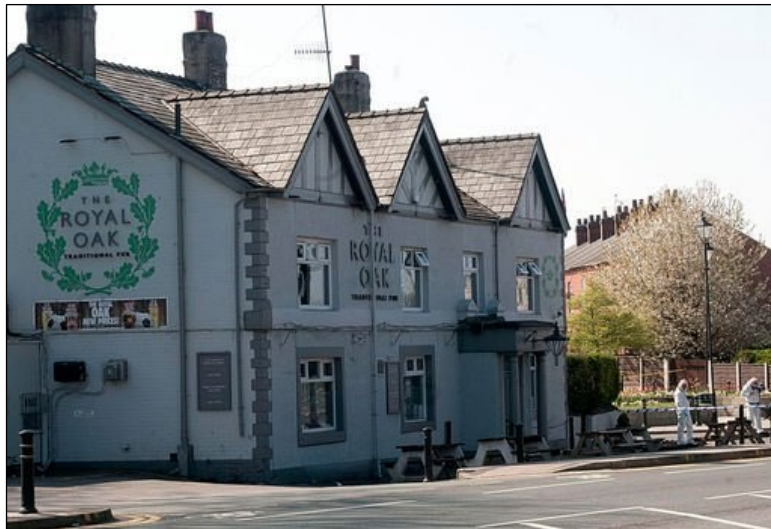
Royal Oak – HER 17959.1.0

| <b>Significance</b> | <p><i>Historic Interest:</i> Writing in the early 1900s, William Souter noted that 'the Royal Oak was built by two brothers, James and Henry Booth, who were silk manufacturers. H Booth went over to the shop...at the other corner of Pole Lane, in 1812. It then became a public house'. The Royal Oak was advertised for sale in May 1843, together with stable, brewhouse, garden and vacant land adjoining, covering 1,095 square yards.</p> <p><i>Architectural Interest:</i> The double-fronted brick facade with its distinctive arched doorway was transformed by taking over a single-storey extension on the north side and building this up to match the rest, and adding a roof with three gable features to the front plane. The detached, two-storey building occupies a prominent location.</p> <p><i>Local Interest:</i> The building is in the historic core of Failsworth, and imparts a sense of historic character to the locale.</p> <p><i>Aesthetic Value:</i> The building is modest in scale and has limited architectural detailing but has some aesthetic value.</p> <p><i>Social / Community Value:</i> The building continues to serve the local community as a public house and is the most recent manifestation of use that has existed on this site since the early 1800s.</p> <p><i>Landmark Status:</i> It is a notable building within the area, occupying a prominent location, and contributes to a sense of place.</p> |

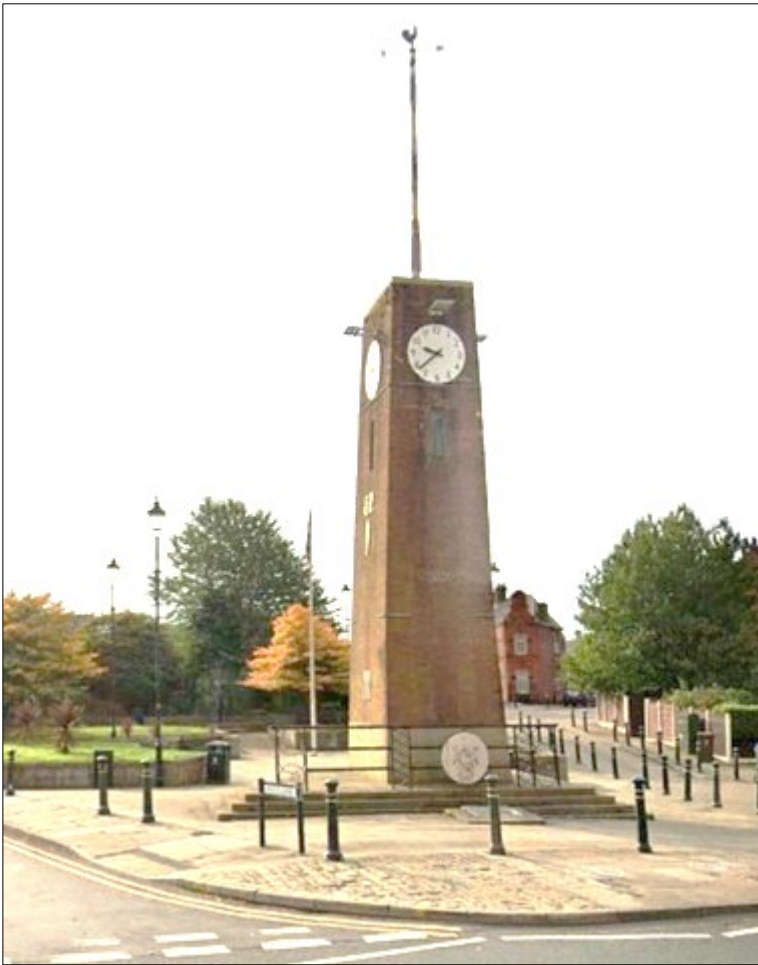
| <b>Property Name and Photo</b> | <p>Failsworth Clock Tower – HER 17960.1.0</p> |

| <b>Significance</b> | <p><i>Historic Interest:</i> A clock tower erected in 1958 on a site long regarded as the heart of Failsworth that featured a maypole in the 18th century prior to the first 'Loyal Standard' pole being erected on 1 January 1793.</p> <p><i>Architectural Interest:</i> The tower is of brick construction with a stepped concrete base.</p> <p><i>Local Interest:</i> The clock tower is located at Failsworth Pole, regarded as the centre of Failsworth. The height of this structure is 54ft, which although shadowed by previous Poles, should withstand a storm. In 2006 the Pole received a £400,000 makeover which saw the clock tower refurbished and a new garden created at its base.</p> <p><i>Aesthetic Value:</i> The structure is of a design that is highly characteristic of the time it was built including the use of materials and their detailed use and the massing that gently narrows from the base to the top.</p> <p><i>Social / Community Value:</i> The building represents a continuation of an historic landmark at the historic centre Failsworth and contributes to a sense of place. As such the building could be expected to have social / community value.</p> <p><i>Landmark Status:</i> The clock tower is a local landmark and makes a considerable contribution to the sense of place and to wayfaring in the locality.</p> |

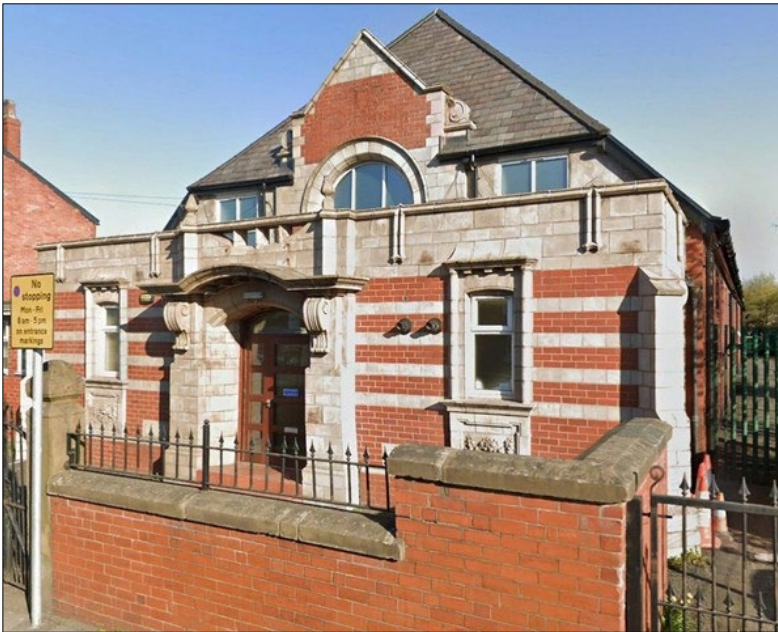
| <b>Significance</b> | <p><i>Historic Interest:</i> The school is marked on the Ordnance Survey 1st Edition 1:2500 map of 1894, but was rebuilt in 1904 to plans by Charles Taylor of Clegg Street, Oldham, and took infant and junior pupils until 1963 when a new school for older pupils was built at James Street.</p> <p><i>Architectural Interest:</i> The school has a rectangular plan form heading back into the site with a narrow frontage to Ashton Road East, and a smaller built form at right angles to the west (side) elevation with two small elements extending from the sides.</p> <p><i>Local Interest:</i> St John's traces its roots back to 1837, when the Church of England established its first National School in Failsworth on Ashton Road East.</p> |

| | <p><i>Aesthetic Value:</i> The building has aesthetic value although this is principally exhibited on the principal (Ashton Road East) elevation.</p> <p><i>Social / Community Value:</i> The building continues to serve the local community as a school and is the most recent manifestation of use that has existed on this site since the 1800s. The building contributes to a sense of place. As such the building could be expected to have considerable social / community value.</p> <p><i>Landmark Status:</i> The school is a notable feature of Ashton Road East.</p> |

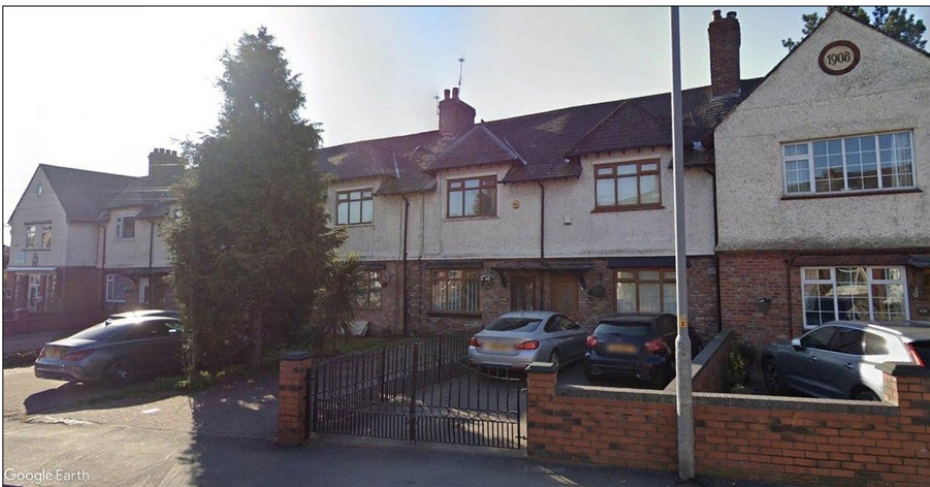
| <b>Significance</b> | <p><i>Historic Interest:</i> A terrace of eight properties erected in 1908 at the corner of Ashton Road East and Argyll Close.</p> <p><i>Architectural Interest:</i> The terrace has Arts and Crafts overtones. It is in brick but with the elevation above the ground floor on the front and side elevations rendered and painted white. The roof is in slate with clay ridge tiles. There is</p> |

| | <p>limited architectural embellishment and fortunately the lean-to front door canopies supported by timber brackets to the seven houses and four chimneys all survive. The terrace today keeps the overall original sense of scale and massing.</p> <p><i>Local Interest:</i> The building is an interesting example of a purpose-built terrace of houses with corner shop surviving reasonably intact. It evidences the historic evolution of this urban area.</p> <p><i>Aesthetic Value:</i> The building is modestly detailed but has aesthetic value despite the replacement of original windows and doors and loss of original front boundary structures.</p> <p><i>Group Value:</i> The terrace has a group value with other elements of the Edwardian built environment on Ashton Road East.</p> <p>Landmark Status: The terrace is a notable feature of Ashton Road East.</p> |

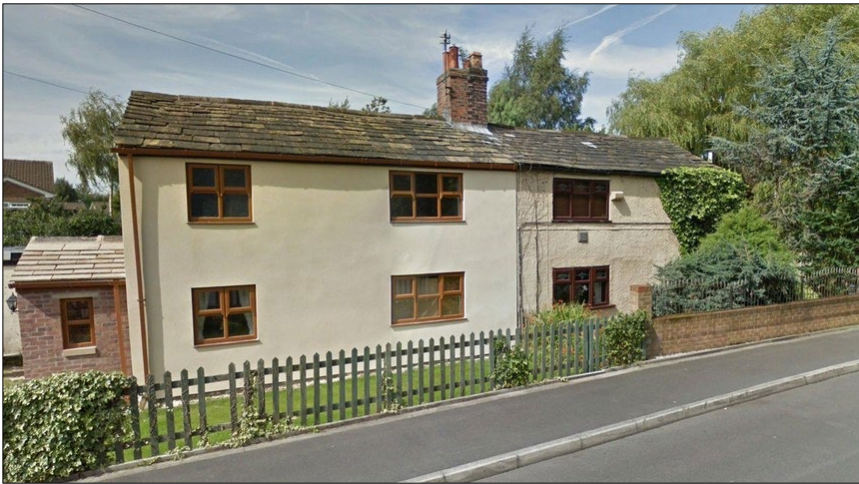
| <b>Significance</b> | <p><i>Historic Interest:</i> The building is shown on the 1848 map and is one of the earliest surviving buildings in this locality and is a visible reminder of its historic urban evolution.</p> <p><i>Architectural Interest:</i> A modest two-storey pair of houses with pitched slate roof with a ridge running parallel to the principal (road) frontage but positioned such that the front pitch is steeper than the rear. Shared central brick chimney survives.</p> <p><i>Local Interest:</i> The houses provide a physical reminder of the area's rural landscape prior to the later 19th century.</p> <p><i>Aesthetic Value:</i> The building retains aesthetic value derived from the modest scale and form, but this has been diminished by more recent change.</p> <p><i>Landmark Status:</i> The building's evident age relative to the surrounding 20th-century houses afford it a landmark status.</p> |

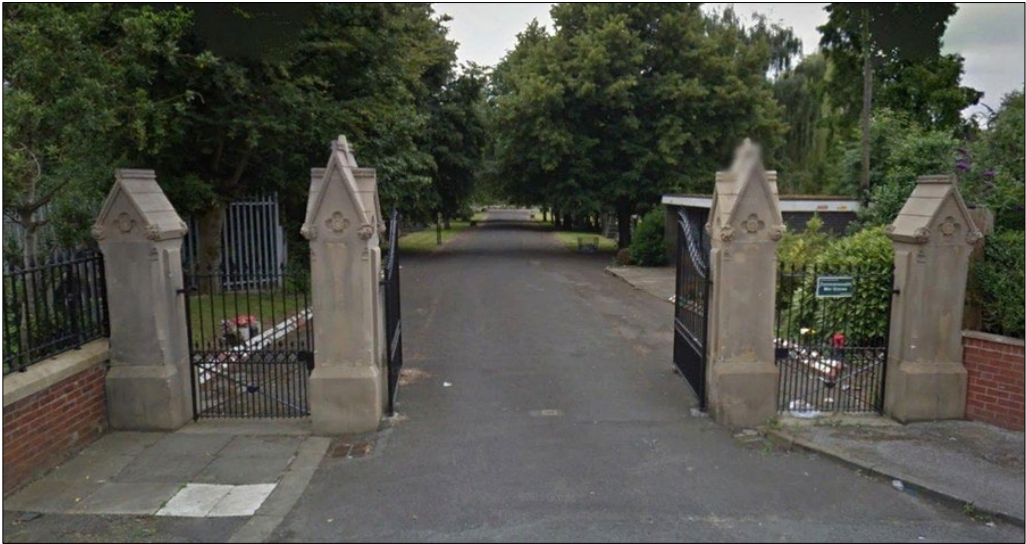
| <b>Significance</b> | <p><i>Historic Interest:</i> Four stone gate posts at the entrance to Failsworth Cemetery, which was established in 1887. The gateposts are of a design that would suggest they are a part of the original design and laying out of the cemetery.</p> <p><i>Architectural Interest:</i> The gates and gate piers are key architectural and historic features that reflect the local heritage and civic pride of the era. They serve as an architectural threshold symbolising respect, dignity, and reverence, marking the transition from public space into sacred ground. Its design helps frame the cemetery as a historical and contemplative site.</p> <p><i>Aesthetic Value:</i> The gates make a positive contribution to the historic character of the entrance to the cemetery.</p> <p><i>Group Value:</i> The gates have a group value with other remaining elements of the original built form associated with the cemetery and with historic grave stones and other funerary monuments/ memorials.</p> |

| | <i>Landmark Status:</i> The entrance gates to the cemetery are a local landmark. |

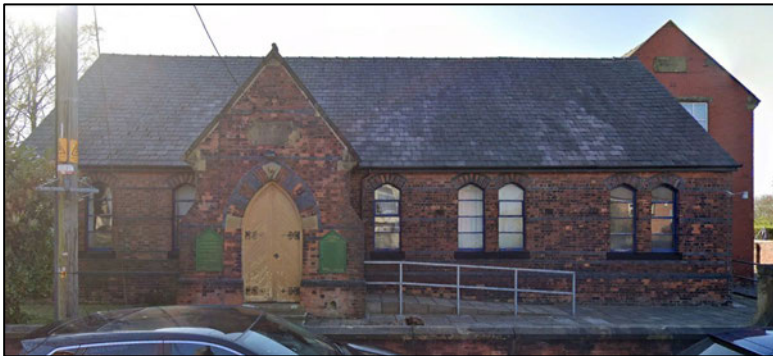
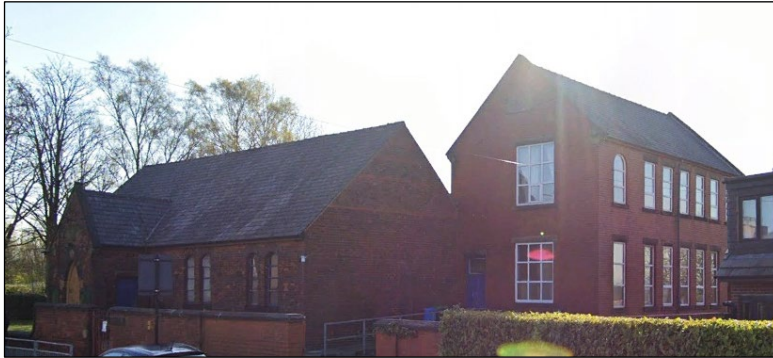
| <b>Property Name and Photo</b> | Woodhouses Church – HER 17965.1.0 |

| <b>Significance</b> | <i>Historic Interest:</i> Woodhouses Church was built as a National School in 1871 following the 1870 Education Act. A date stone sits above the Gothic arched doorway within the north porch facing Ashton Road. |

| | <p><i>Architectural Interest:</i> The original design intent of the original school/church building and 1912 extension remain largely intact. The older building is principally in brick with limited architectural embellishment which is largely achieved by polychromatic brickwork and detailing to heads of elevation openings. Viewed from Ashton Road the church features a Gothic arched doorway with brick and stone detail above.</p> <p><i>Local Interest:</i> An extension was constructed to the west of the site in 1912 and is dedicated by way of date stone to a person named Charles Cliff, who was born in the village.</p> <p><i>Aesthetic Value:</i> The building is visible evidence of the historic urban evolution of the locality and contributes to a sense of place.</p> <p><i>Social /Communal Value:</i> Having performed the dual role of church and school for the village of Woodhouses, the building has played a significant role in the lives of local residents for over 150 years. This includes funeral services, wedding ceremonies and community events.</p> <p><i>Landmark Status:</i> The school is a local landmark.</p> |

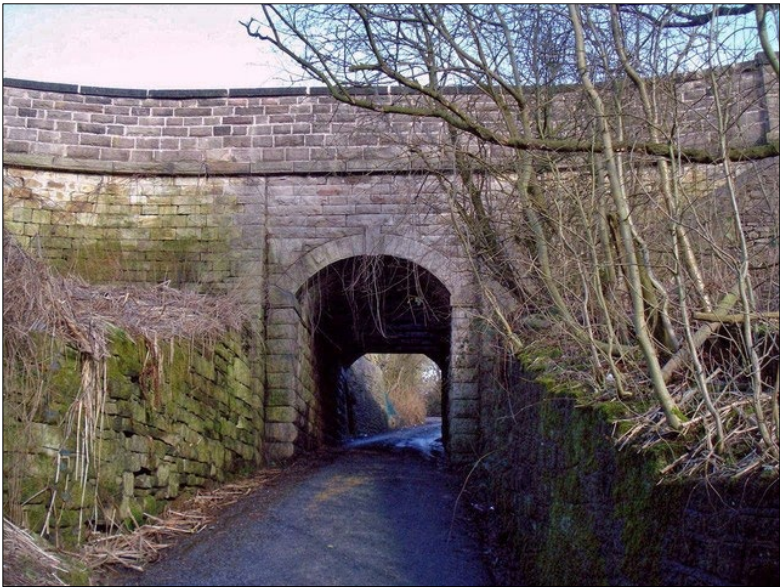
| <b>Significance</b> | <p><i>Historic Interest:</i> Canal aqueduct built in 1797 on the Hollinwood Branch of the Ashton Canal with modifications in 1859. Navigation channel carried in iron trough across the narrow Crime Lane.</p> <p><i>Architectural Interest:</i> Stone arches and wing walls. Stone parapet to towpath side. Canal channel carried in trough with bottom of six iron plates with brickwork above.</p> <p><i>Local Interest:</i> Datestone over south-west face shows 1859, indicating that there had been some rebuilding of the stonework here, but ironwork of the navigation trough appears to be original from 1797.</p> <p><i>Aesthetic Value:</i> The aqueduct has considerable aesthetic value and makes a positive contribution to the historic character of the locale.</p> <p><i>Rarity Value:</i> One of the first navigable iron aqueducts in the world.</p> |

| | <p><i>Group Value:</i> The aqueduct has a strong group value with other canal features.</p> <p><i>Landmark Status:</i> It is a notable feature on both the canal and highway routes.</p> |

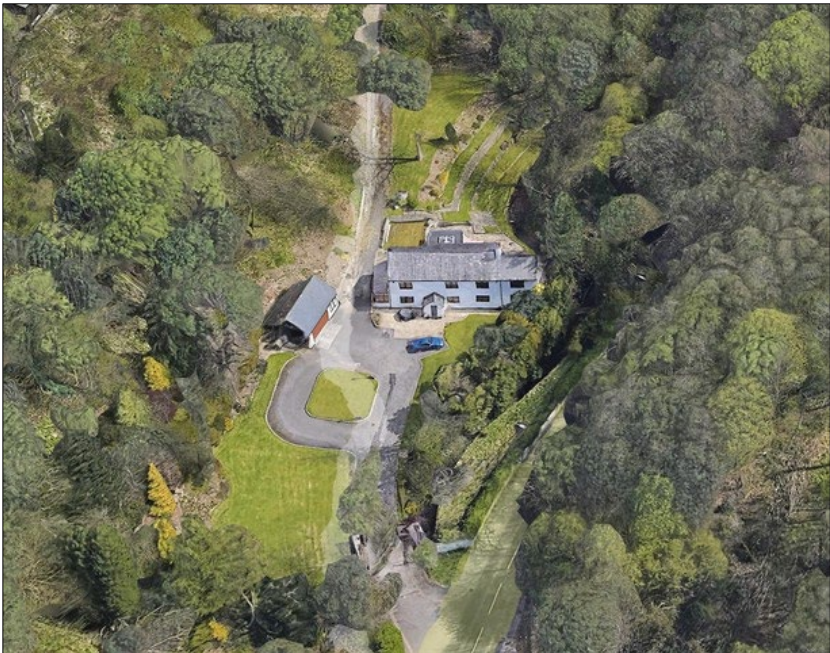
| <b>Significance</b> | <p><i>Historic Interest:</i> The building is marked on the Ordnance Survey 1st Edition 1:10,560 map of 1848, but is thought to date to the 1650s.</p> <p><i>Architectural Interest:</i> The building is principally of two storeys with several small-scale single-storey elements. The single storey highly glazed extension with lantern rooflight to the rear is a more recent addition but the other single-storey elements may well be original or historic. The building is wholly rendered and painted white which makes it more difficult to identify areas of change. The roofs remain in slate. Only one chimney is visible, but more would have been originally/historically expected on a house of this size.</p> |

| | <p><i>Local Interest:</i> The farm buildings provide a physical reminder of the area's rural landscape and the importance of agriculture to the local economy prior to the later 19th century. It was formerly the home to Minnie Higginbottom.</p> <p><i>Aesthetic Value:</i> The building is visible evidence of the historic evolution of the locality and contributes to a sense of place.</p> <p>Group Value: The farm has a group value with other former agricultural buildings in Daisy Nook, including the Grade II listed barn to Daisy Nook Farm.</p> <p><i>Landmark Status:</i> The farm is a notable feature of the local historic landscape.</p> |

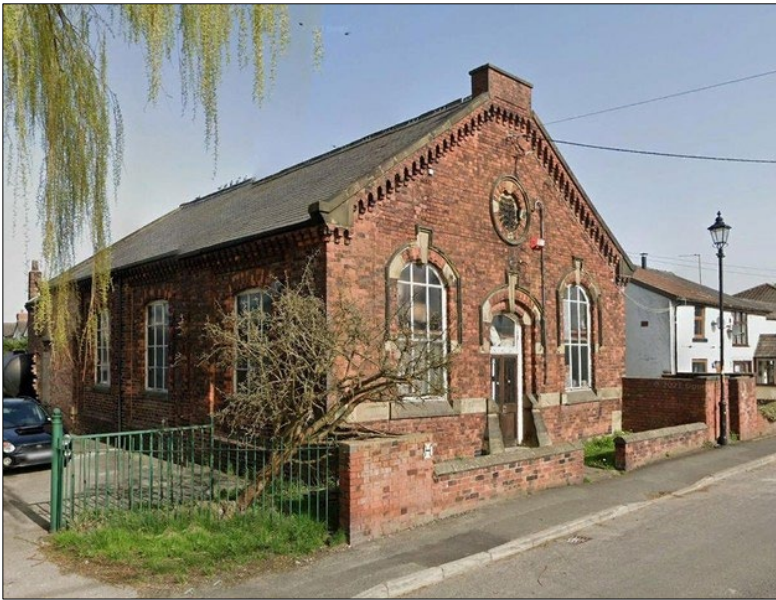
| <b>Significance</b> | <p><i>Historic Interest:</i> The school is first shown on the Ordnance Survey 1st Edition 1:2500 map of 1894. A carved roundel on the principal (south-east) elevation fronting Medlock Road reads “Woodhouses British Schools Re-****ted 1886”.</p> <p><i>Architectural Interest:</i> A detached, single-storey building with the south-eastern gable overlooking Medlock Road. This gable elevation contains the main entrance in the centre with tall arched windows on either side. The building is of brick construction with a pitched slate roof and stone detailing; stone is employed for the window sills, which continue to form a string course along the front gable elevation.</p> <p><i>Local Interest:</i> The school has served local residents for more than a century and continues to fulfil a key role for the Woodhouses community.</p> <p><i>Aesthetic Value:</i> The former school makes a positive contribution to the historic character of the locale.</p> |

| | <p><i>Social/Communal Value:</i> As a school the building will have played a significant role in the lives of local residents.</p> <p><i>Group Value:</i> The school has a group value with other elements of the 19th-century historic built environment.</p> <p><i>Landmark Status:</i> The school is a notable historic feature of Medlock Road.</p> |
